Manhole Inspection Summary

Manhole # S25EE1039MH

Insp Date: **1/23/07 1:20 PM**

Location Address: **3917 CROWTHER ST**

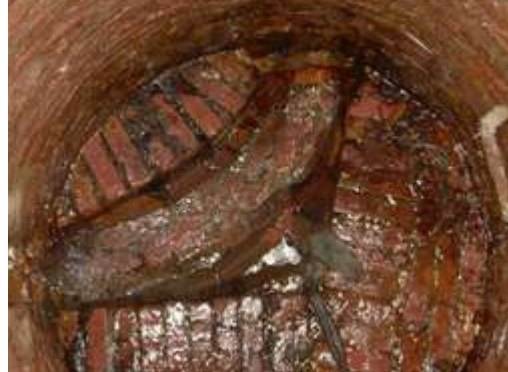
Top View

Corroded steps. Bench debris.

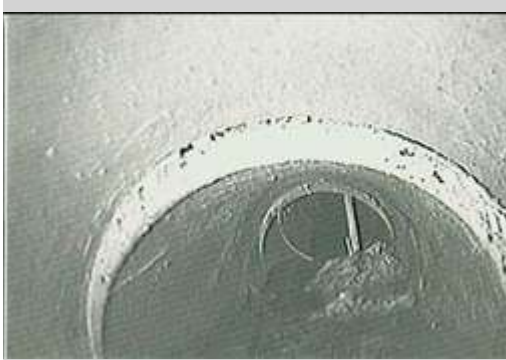
Inside of the I9

Offset joints.

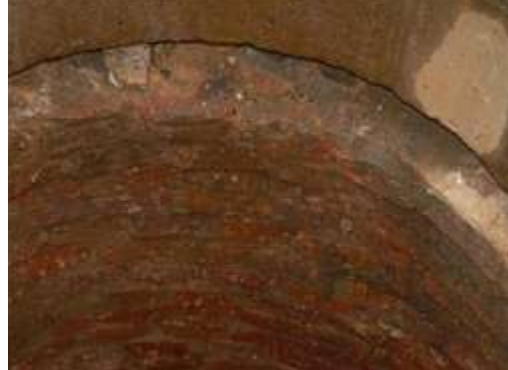
Defect

☒ **Leaks**

Condition: ☐ Sound ☐ Cracked ☐ Root Intrusion ☒ **Loose Brick** ☒ **Deteriorated**

Infiltration: ☐ None ☒ **Joint** ☐ Cracks ☒ **Mortar** ☐ Roots ☒ **Wall**

Frame leaks. Frame offset. Adjustment deterioration and infiltration - other side.

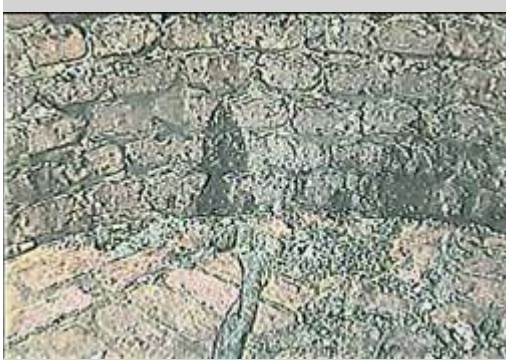
Defect

Condition: ☐ Sound ☐ Cracked ☐ Root Intrusion ☐ Loose Brick ☒ **Deteriorated**

Infiltration: ☐ None ☐ Joint ☐ Cracks ☒ **Mortar** ☐ Roots ☒ **Wall**

Barrel deterioration and infiltration.

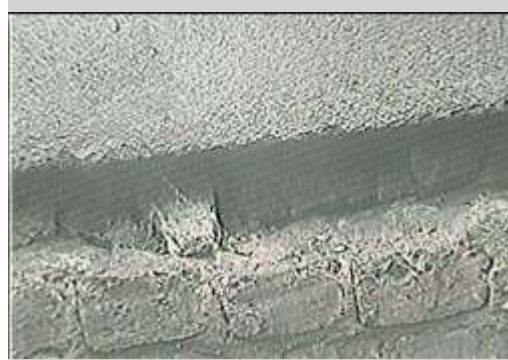
Defect

Frame leaks. Adjustment deterioration and infiltration.

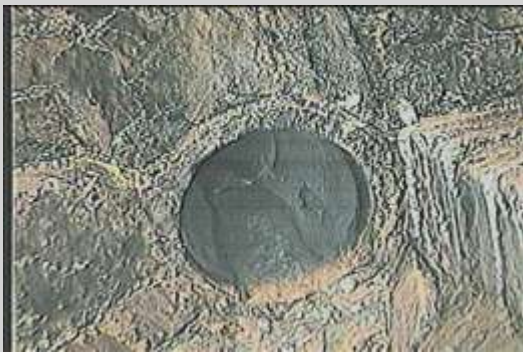
8 in. Circular Gravity Sewer Pipe Out @ 12 O'Clock

Barrel deterioration and infiltration. Channel deterioration.

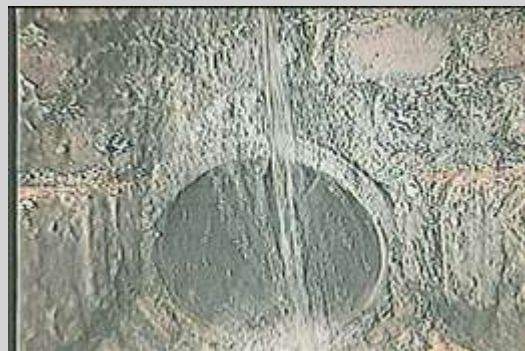
Drop In @ 9 O'Clock

Barrel deterioration and infiltration. Channel deterioration.

Drop Condition: **Partly Clogged**
